Manhole Inspection Summary

Manhole # S25K__001MH

Insp Date: **3/27/08 9:56 AM**

Location Address: **1312 Kuper St (nwc)**

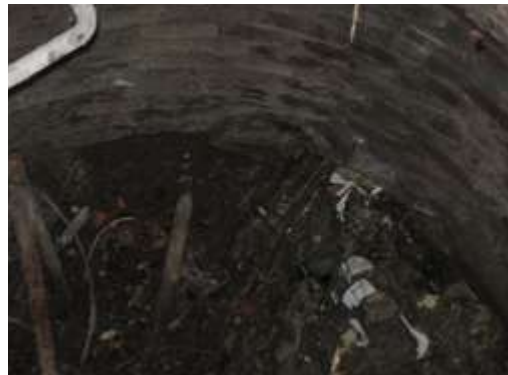
Defect 1

Condition: ☐ Sound ☐ Cracked ☐ Root Intrusion ☐ Deteriorated ☐ Leaks ☒ **Debris**

debris blocking channel

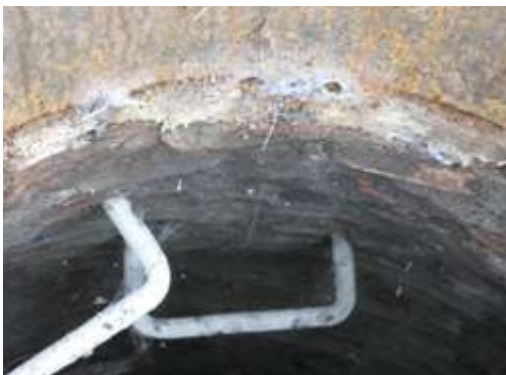
Defect 2

Condition: ☐ Sound ☐ Cracked ☐ Root Intrusion ☐ Loose Brick ☒ **Deteriorated**

Steps Count: **3** Missing: **0** ☒ **Corroded**

steps corroded, missing mortar under frame

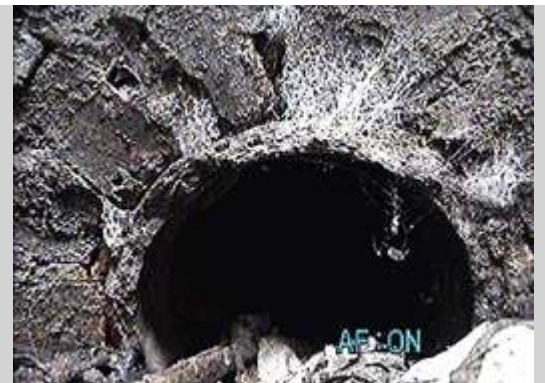
12 O'Clock Outflow

8 in. Circular Gravity Sewer
Pipe Out @ 12 O'Clock
